## USING EXPOSURE TEXTS TO EXAMINE ROUGING OF STAINLESS STEEL

Pharmaceutical Engineering July / August 2002

This article presents the results of an experimental study conducted to support the basic understanding of the rouging phenomenon that often occurs on stainless steel in WFI systems. With the established exposure technique, it is shown that rouging is affected by the surface quality and composition of gas atmosphere.

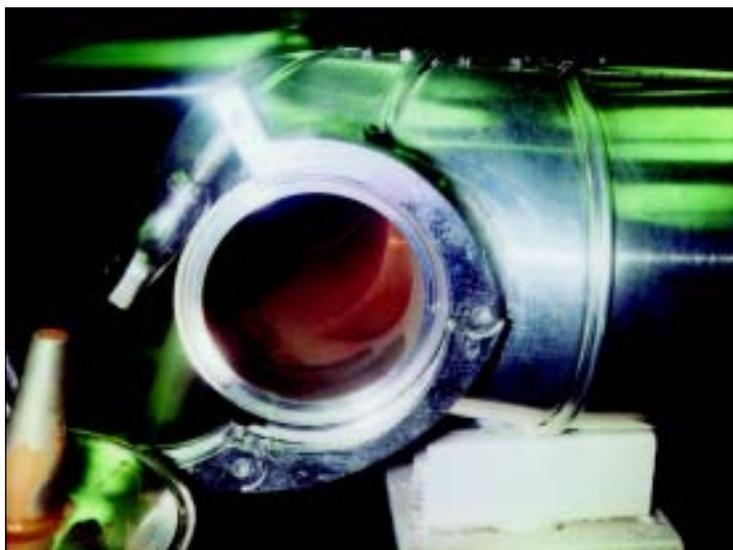
Figure 1. Rouging on the internal surfaces of a WFI system.<sup>5</sup>

For many years, numerous cases of red-brown to dark violet deposits on the inside surface of distillation columns, storage vessels, and distribution systems for hot purified water and clean steam have been reported. Due to the visual appearance, those deposits were referred to as *rouge*. Rouge was observed in pharmaceutical Water for Injection (WFI) systems, which are typically made of austenitic CrNiMo steel grade AISI 316L. The formation of rouge is promoted by elevated temperatures above 60°C - *Figure 1*.

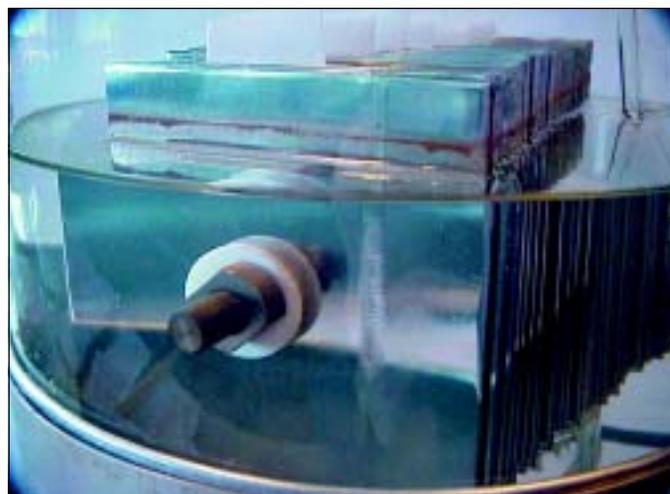
Figure 2. Test cell with a coupon rack showing rouge at the water line after three weeks of exposure in nitrogen purged WFI (boiling was paused). The coupons include both the #80 and the 2B+ep finish of 316L material.

The first signs of rouge became visible after four days of exposure while only little development was observed during the remaining exposure period. In all cases, rouge was seen as deposits along the water line of the coupons as shown in Figure 2. The most evident rouge formation was seen in the cells purged with nitrogen or air with addition of carbon dioxide. The

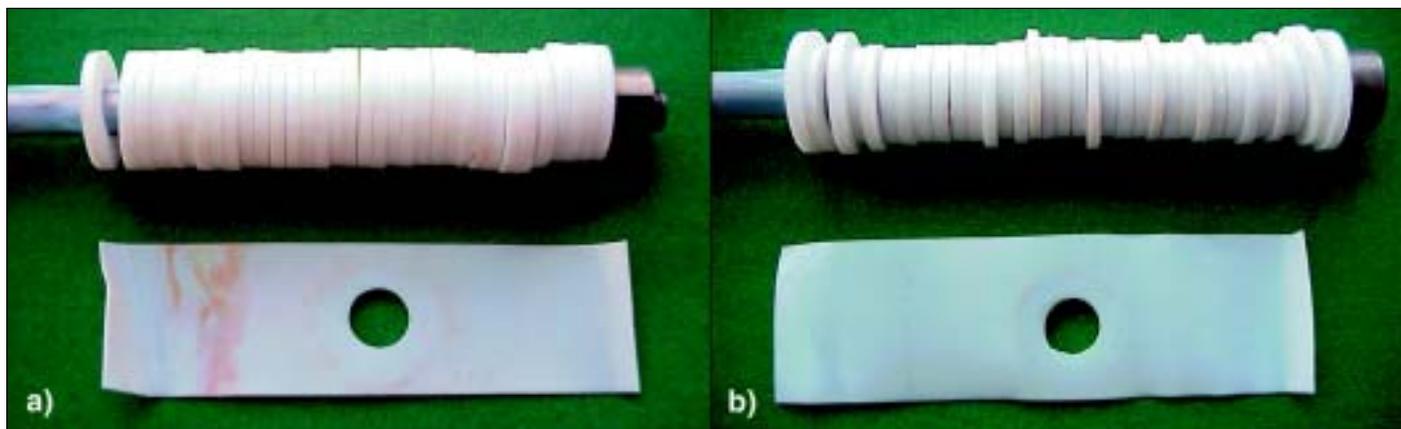
Figure 3. Teflon spacers and strips after exposure of 316L in WFI purged with a) air + 1% CO<sub>2</sub> and b) Air + CO<sub>2</sub>.

two other atmospheres (air and air + CO<sub>2</sub>) showed less or no rouge formation. This became clear when the coupons and Teflon strips were studied closely after dismantling the cells - Figure 3.

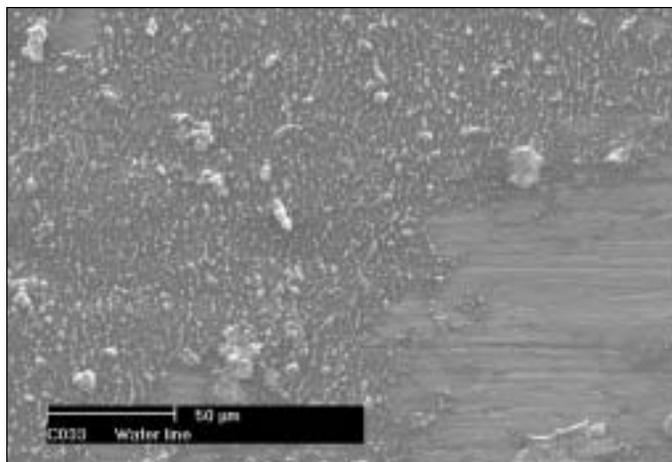
Figure 4. Exposed coupon covered by loosely adhered rouge deposits. Scanning electron micrograph.

the coupons showed that the rouge product consists of relatively loosely adhered particles - Figure 4. However, since the rouge was evenly distributed on the strips and coupons, the first series of tests did not allow any distinction between the different surface treatments.

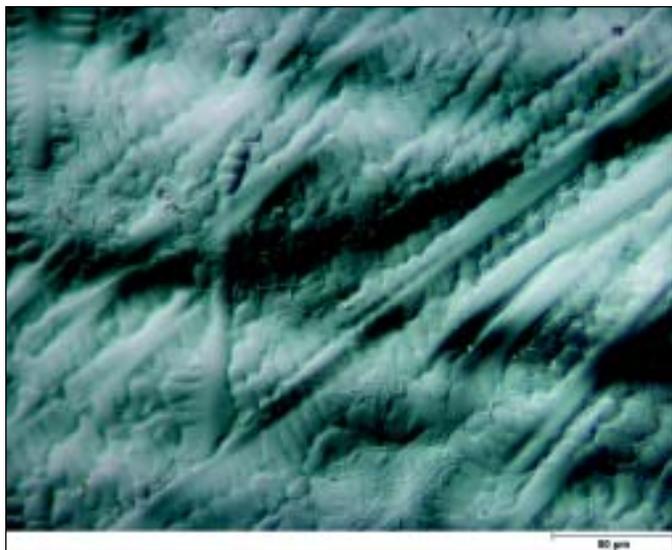
Figure 5. Weld metal of an electropolished 316L coupon. The picture was obtained by light microscopy and shows a small amount of delta ferrite distributed as a skeleton between the primary austenitic phase.

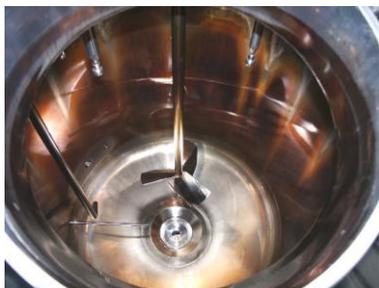
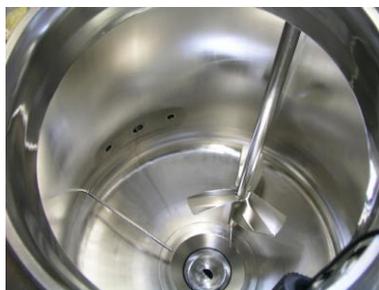
*Stainless steel tank, material 1.4435  
before and after surface treatment on-site  
with optimized Henkel-procedure*
